Infrared Testing Survey Report

Prepared For:
Company Name
Company Address

Current Date
Job Number: 777

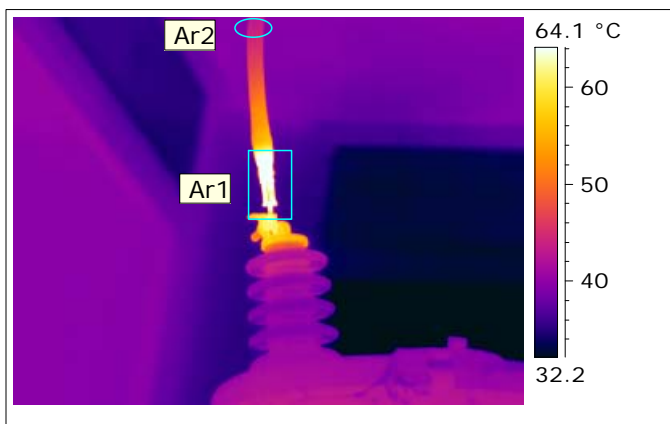
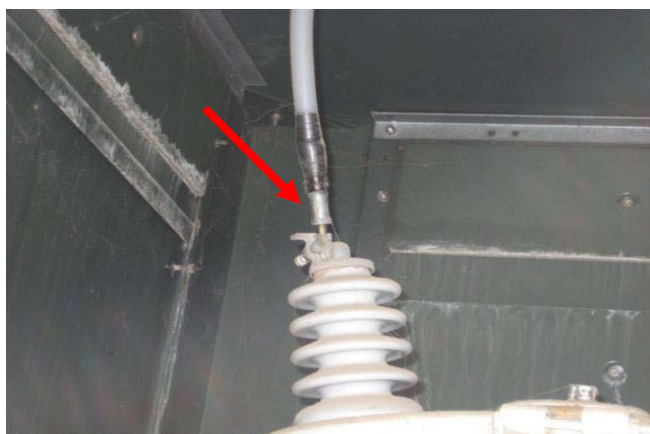
Object Parameters	Value
Filename	IR_1433.jpg
Maximum Temperature	72
Control Temperature	45
Temperature Rise	27
Severity	Serious

Location	South Side Of Building Transclosure East Can West High Voltage Connection
Equipment	250 KVA Transformer
Type	Termination
Image Date	9/17/2008
Image Time	2:04:31 PM
Recommendation	Repair

The crimp connection above shows a 27°C rise as compared to the cable connected. The thermal image is taken from the opposite side to get a better angle. The termination needs to be remade with the proper crimp terminal, using the appropriate crimp tool. There is also oil leaking from this transformer at the secondary bushing. Repairs should be made at the next available shut down using qualified High Voltage personnel.

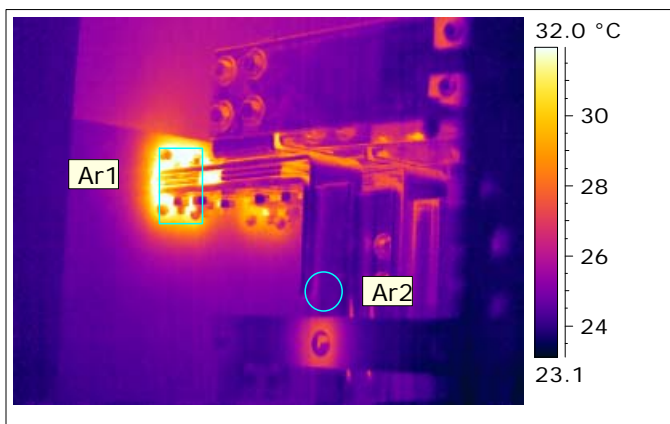
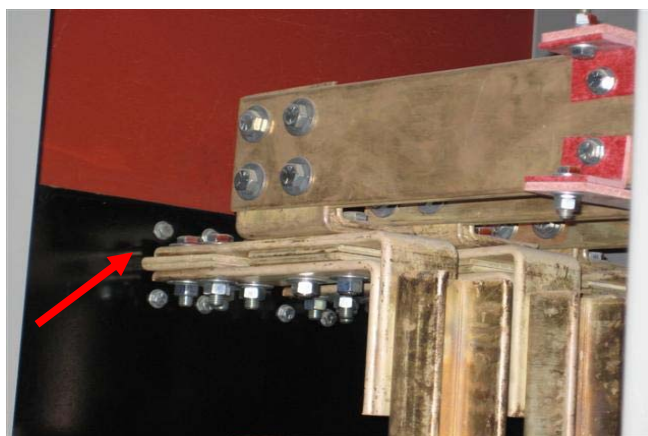
Object Parameters	Value
Filename	IR_1988.jpg
Maximum Temperature	35
Control Temperature	26
Temperature Rise	9
Severity	Intermediate

Location	Basement U.P.S. Room A.T.S. 3 Right Phase Rear Stab
Equipment	A.T.S. 3
Type	RTBD-200003C-VS
Image Date	11/14/2008
Image Time	2:49:33 PM
Recommendation	Clean, Lube And Exercise

This is the rear view of A.T.S. 3. The right phase line side stab that connects A.T.S. 3 to the switchgear bus assembly shows an external 10°C rise when compared to the bus connected. A.T.S. 3 is critical to the facility, as the life safety panels are being fed from the switch. Clean, lubricate, and exercise the switch at the next available shutdown.

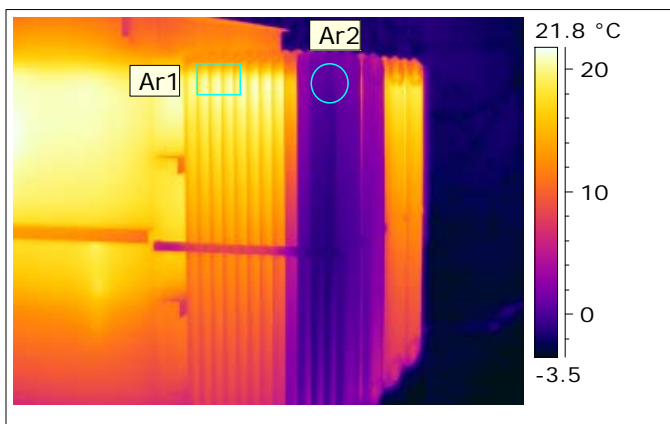
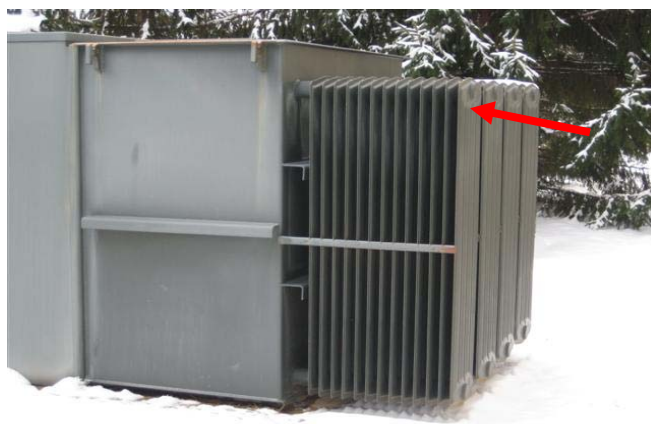
Object Parameters	Value
Filename	IR_2106.jpg
Maximum Temperature	21
Control Temperature	2
Temperature Rise	19
Severity	Intermediate

Location	North Side Of Plant East Cooling Fin
Equipment	2000 KVA Transformer
Type	Oil Cooling Fin
Image Date	12/18/2008
Image Time	1:44:01 PM
Recommendation	Check Fluid Level

The north end of the oil cooling fin above shows a 19°C rise as compared to the southern most fins. This is most likely due to a low oil level within the transformer or blockage in the tube. The transformer should be serviced by qualified personnel to further validate the infrared inspection. It is also recommended to perform the annual gas in oil analysis while the transformer is de-energized.

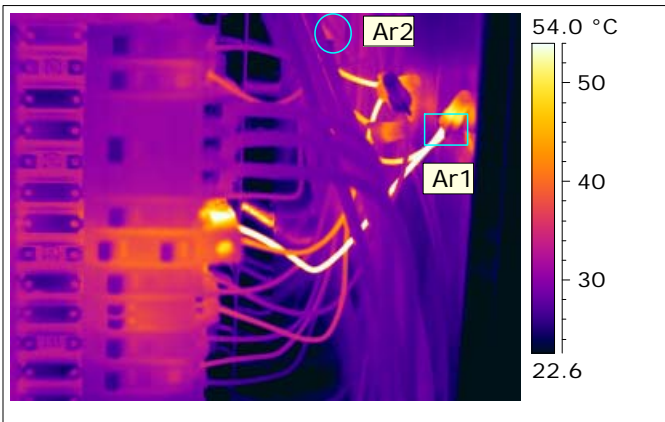
Object Parameters	Value
Filename	IR_4779.jpg
Maximum Temperature	68
Control Temperature	37
Temperature Rise	31
Severity	Serious

Location	Rear Of Facility Electrical Room Panel M Breaker 12
Equipment	Panel M
Type	Wire Splice Connection
Image Date	5/5/2010
Image Time	7:22:36 AM
Recommendation	Repaired During Inspection

The wire connection to the tandem breaker above shows a 36°C rise. The wire terminated to the breaker was a #14 gauge conductor. Per the National Electrical Code, the minimum size wire that can be connected to a 20 amp breaker is a 12 gauge wire. The conductor and the wire splice were replaced during the inspection. No further action is required.

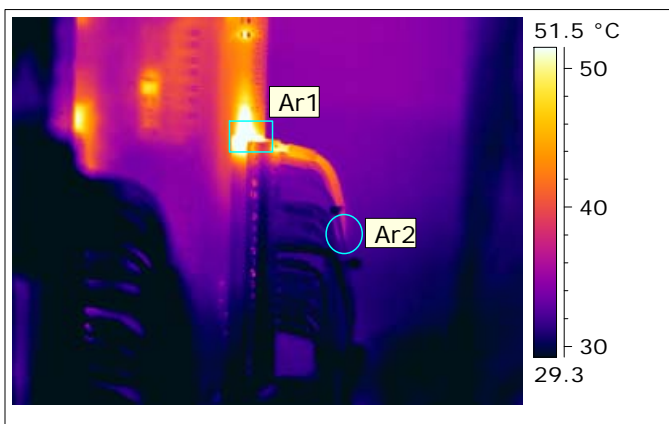
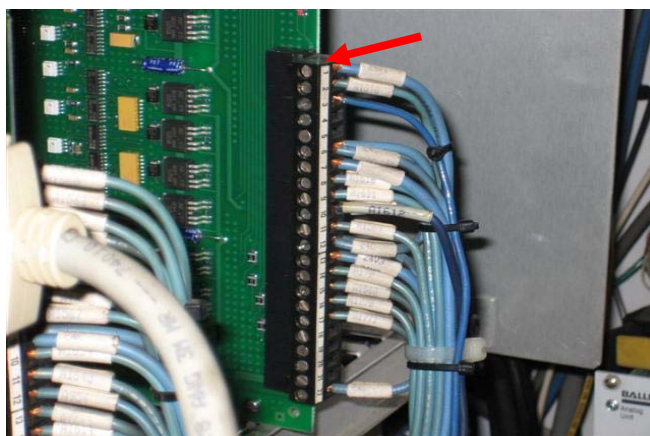
Object Parameters	Value
Filename	IR_2981.jpg
Maximum Temperature	74
Control Temperature	38
Temperature Rise	36
Severity	CRITICAL

Location	Press 60 Main Control Cabinet Far Right Control Board Top Wire Termination
Equipment	Press 60 Control Board
Type	Wire Termination Connection
Image Date	4/16/2009
Image Time	10:02:46 AM
Recommendation	Clean Wire and Termination Lug

The connector to the PLC input board shows a 39°C rise. It appears that there is a loose solder connection on the input board. Replace the input board to avoid possible down time and subsequent loss of production.

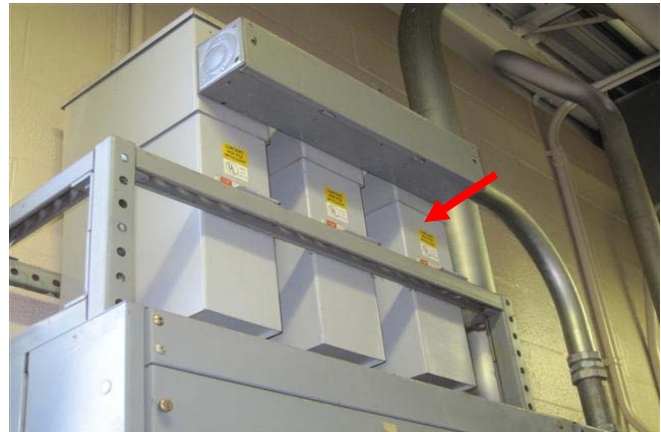
Object Parameters	Value
Filename	IR_3450.jpg
Maximum Temperature	43
Control Temperature	31
Temperature Rise	12
Severity	Intermediate

Location	Main Electrical Room Capacitor Bank Right Capacitor
Equipment	Capacitor Bank
Type	Capacitor
Image Date	8/6/2009
Image Time	7:23:02 AM
Recommendation	Repair Or Replace

It appears the capacitor on the far right is not functioning as it should. All fuses in the feed switch for the capacitor were functioning at the time of the inspection. Amp readings confirmed that the capacitor is not operational. The capacitor should be serviced and tested to insure that it is functioning properly.

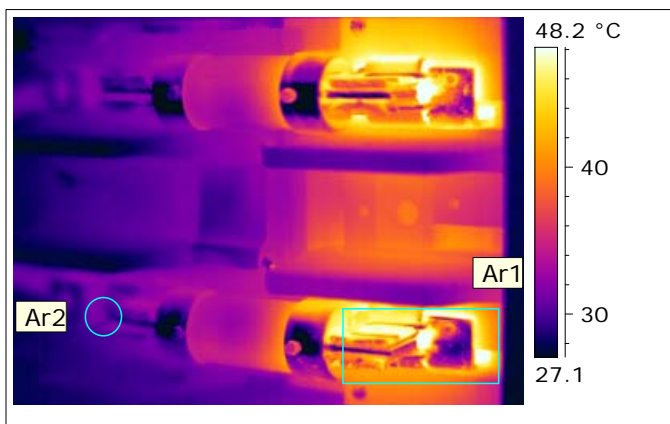
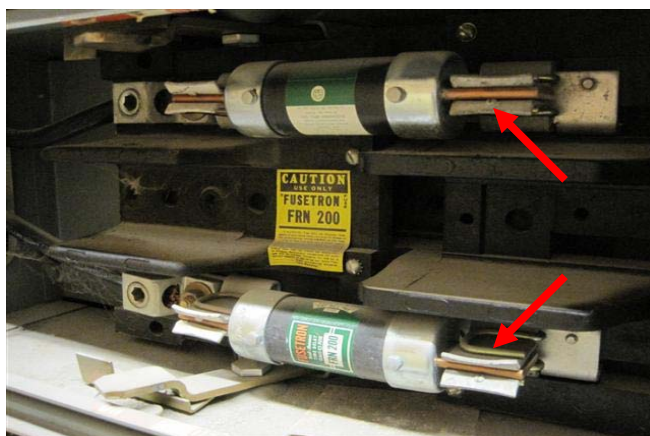
Object Parameters	Value
Filename	IR_4807.jpg
Maximum Temperature	51
Control Temperature	32
Temperature Rise	19
Severity	Intermediate

Location	Rear Of Facility 3d Distribution Section From Left 2nd Switch Down
Equipment	Panel H
Type	QMB-2220
Image Date	5/5/2010
Image Time	12:09:05 PM
Recommendation	"Clean, Lubricate and Exercise"

The top and bottom phase line side QMB switch to panel bus connection above shows a 19°C rise. Inspect the knife blade and pivot for arcing. Also inspect the connection on the bus of the distribution panel. It appears that the source of the heat is coming from behind the Bakelite This indicates a connection issue either at the bus or at the knife connection.

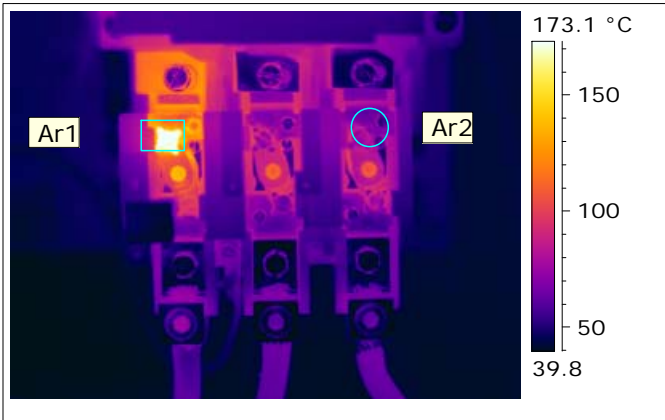
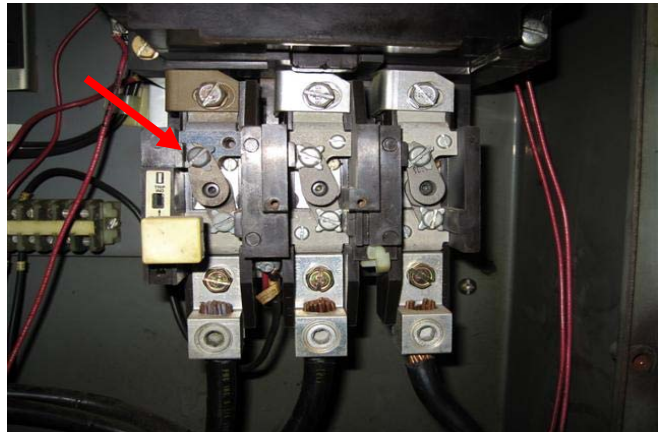
Object Parameters	Value
Filename	IR_4615.jpg
Maximum Temperature	191
Control Temperature	89
Temperature Rise	102
Severity	CRITICAL

Location	Compressor Room Compressor 1 Left Phase Overload Connection
Equipment	Compressor 1
Type	Overload Connection
Image Date	4/15/2010
Image Time	10:58:01 AM
Recommendation	Disassemble and Inspect Components

The top connection of the left phase motor overload heater under the main motor contactor shows a critical 101°C rise. This item was written up in the 1-07 report as a 72°C rise and later in the 1-08 report as a 51°C rise. The repair that was attempted from last years report was only minimally successful. Replace the entire overload block and overload heaters to keep this crucial piece of equipment operating.
