Infrared Testing Survey Report

Prepared For:
Company Name
Company Address

Current Date
Job Number: 777

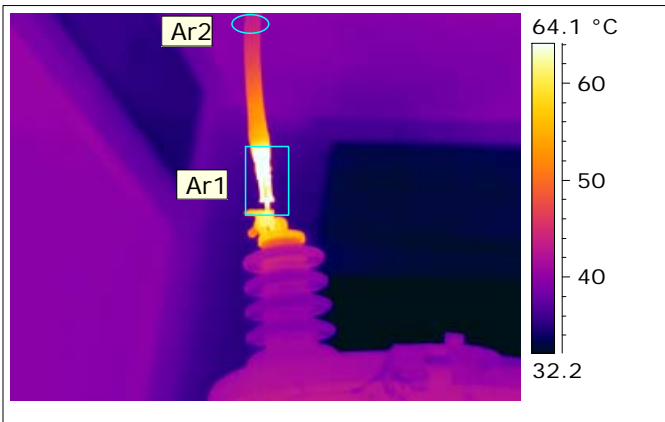
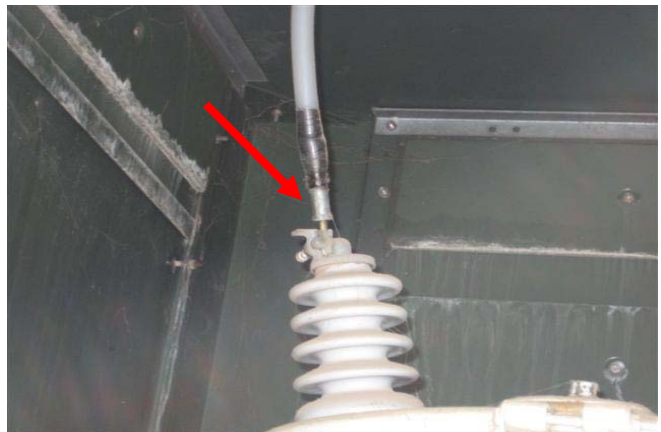
Object Parameters	Value
Filename	IR_1433.jpg
Maximum Temperature	72
Control Temperature	45
Temperature Rise	27
Severity	Serious

Location	South Side Of Building Transclosure East Can West High Voltage Connection
Equipment	250 KVA Transformer
Type	Termination
Image Date	9/17/2008
Image Time	2:04:31 PM
Recommendation	Repair

The crimp connection above shows a 27°C rise as compared to the cable connected. The thermal image is taken from the opposite side to get a better angle. The termination needs to be remade with the proper crimp terminal, using the appropriate crimp tool. There is also oil leaking from this transformer at the secondary bushing. Repairs should be made at the next available shut down using qualified High Voltage personnel.

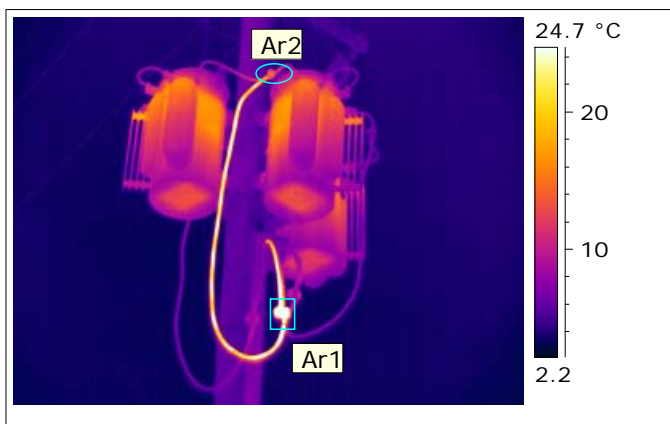
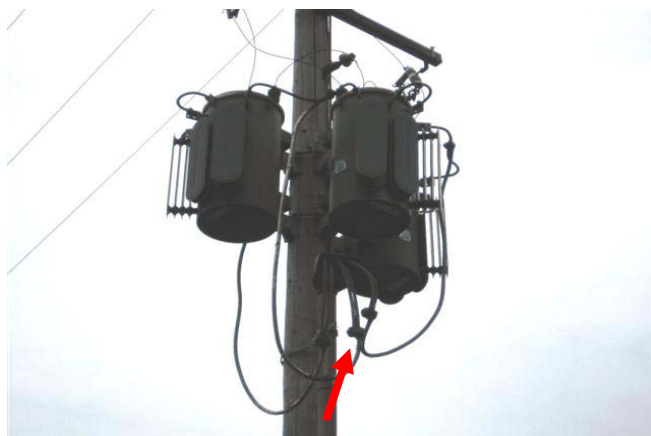
Object Parameters	Value
Filename	IR_1948.jpg
Maximum Temperature	45
Control Temperature	20
Temperature Rise	25
Severity	Serious

Location	Foundry Area North Parking Lot
Equipment	Pole Mount Transformer Secondary Connection
Type	Wye Connection
Image Date	11/12/2008
Image Time	11:03:09 AM
Recommendation	Repair Splice Connection

The secondary connection from the west transformer shows a 25°C rise. This is an 11°C rise in temperature since the 2007 report. During the next outage this connection wire should be replaced (between the transformer and splice) and a new connection made. Keep in mind that the actual temperature at the connection will be considerably higher after factoring in ambient air temperature and distance.

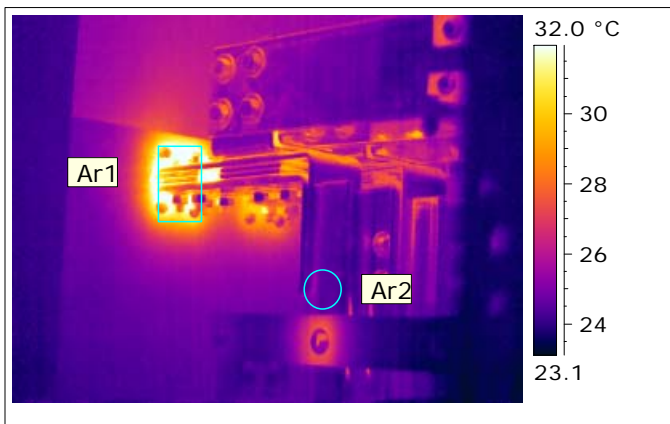
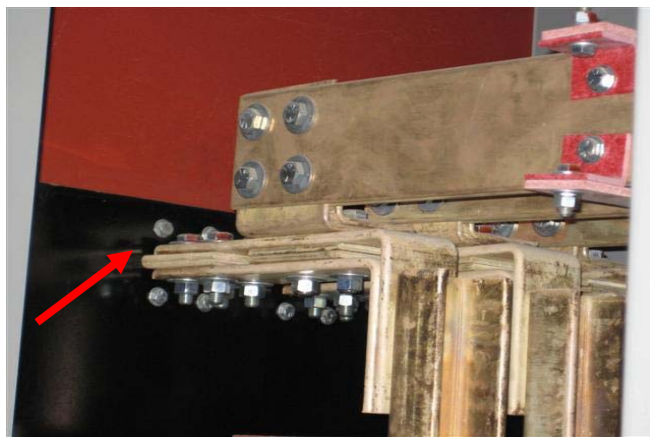
Object Parameters	Value
Filename	IR_1988.jpg
Maximum Temperature	35
Control Temperature	26
Temperature Rise	9
Severity	Intermediate

Location	Basement U.P.S. Room A.T.S. 3 Right Phase Rear Stab
Equipment	A.T.S. 3
Type	RTBD-200003C-VS
Image Date	11/14/2008
Image Time	2:49:33 PM
Recommendation	Clean, Lube And Exercise

This is the rear view of A.T.S. 3. The right phase line side stab that connects A.T.S. 3 to the switchgear bus assembly shows an external 10°C rise when compared to the bus connected. A.T.S. 3 is critical to the facility, as the life safety panels are being fed from the switch. Clean, lubricate, and exercise the switch at the next available shutdown.

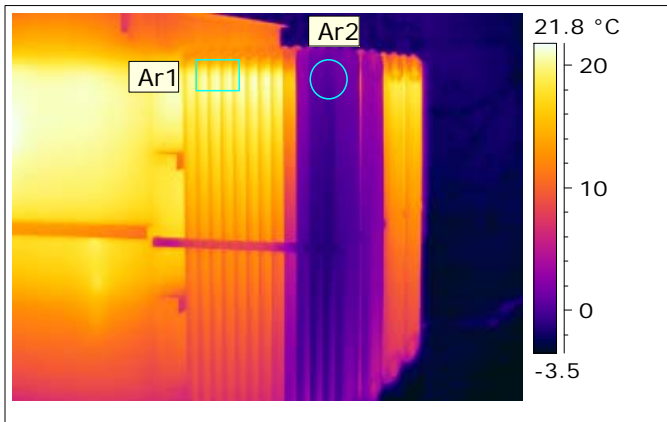
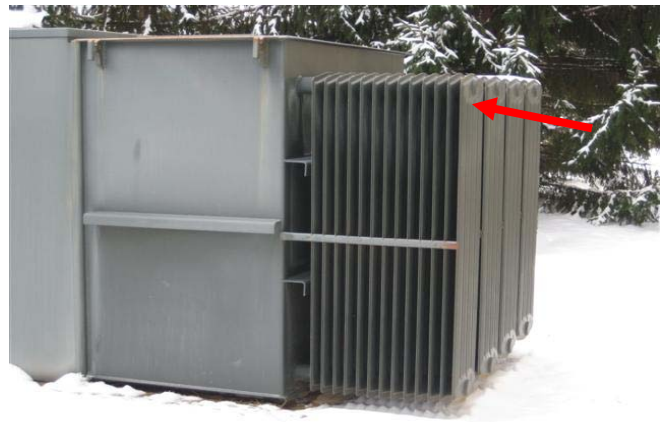
Object Parameters	Value
Filename	IR_2106.jpg
Maximum Temperature	21
Control Temperature	2
Temperature Rise	19
Severity	Intermediate

Location	North Side Of Plant East Cooling Fin
Equipment	2000 KVA Transformer
Type	Oil Cooling Fin
Image Date	12/18/2008
Image Time	1:44:01 PM
Recommendation	Check Fluid Level

The north end of the oil cooling fin above shows a 19°C rise as compared to the southern most fins. This is most likely due to a low oil level within the transformer or blockage in the tube. The transformer should be serviced by qualified personnel to further validate the infrared inspection. It is also recommended to perform the annual gas in oil analysis while the transformer is de-energized.

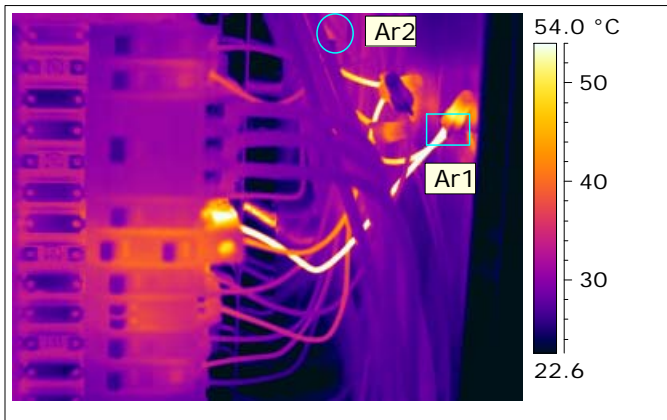
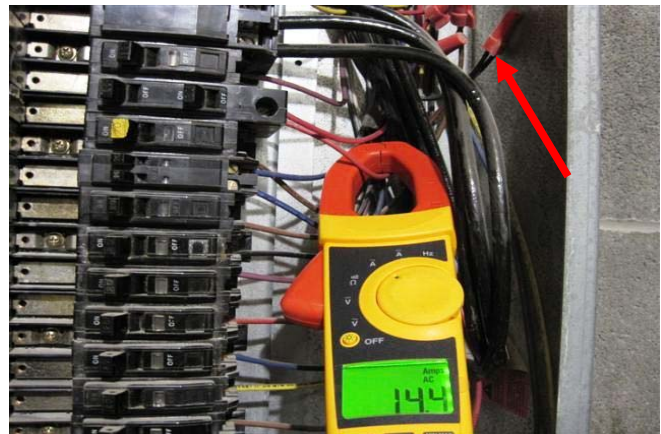
Object Parameters	Value
Filename	IR_4779.jpg
Maximum Temperature	68
Control Temperature	37
Temperature Rise	31
Severity	Serious

Location	Rear Of Facility Electrical Room Panel M Breaker 12
Equipment	Panel M
Type	Wire Splice Connection
Image Date	5/5/2010
Image Time	7:22:36 AM
Recommendation	Repaired During Inspection

The wire connection to the tandem breaker above shows a 36°C rise. The wire terminated to the breaker was a #14 gauge conductor. Per the National Electrical Code, the minimum size wire that can be connected to a 20 amp breaker is a 12 gauge wire. The conductor and the wire splice were replaced during the inspection. No further action is required.

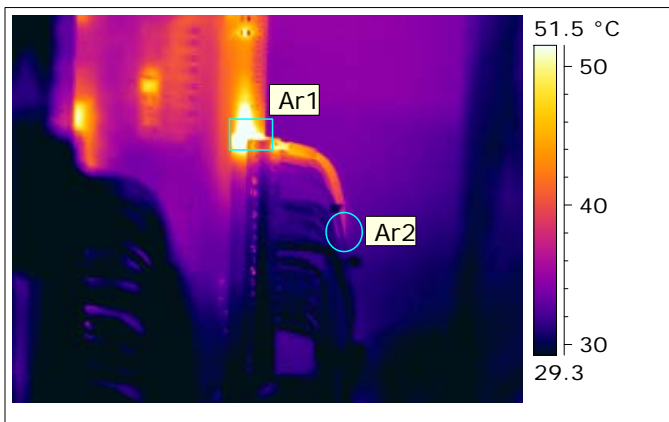
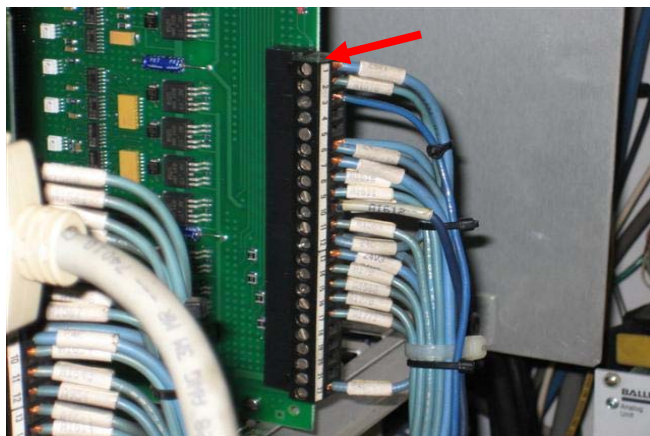
Object Parameters	Value
Filename	IR_2981.jpg
Maximum Temperature	74
Control Temperature	38
Temperature Rise	36
Severity	CRITICAL

Location	Press 60 Main Control Cabinet Far Right Control Board Top Wire Termination
Equipment	Press 60 Control Board
Type	Wire Termination Connection
Image Date	4/16/2009
Image Time	10:02:46 AM
Recommendation	Clean Wire and Termination Lug

The connector to the PLC input board shows a 39°C rise. It appears that there is a loose solder connection on the input board. Replace the input board to avoid possible down time and subsequent loss of production.

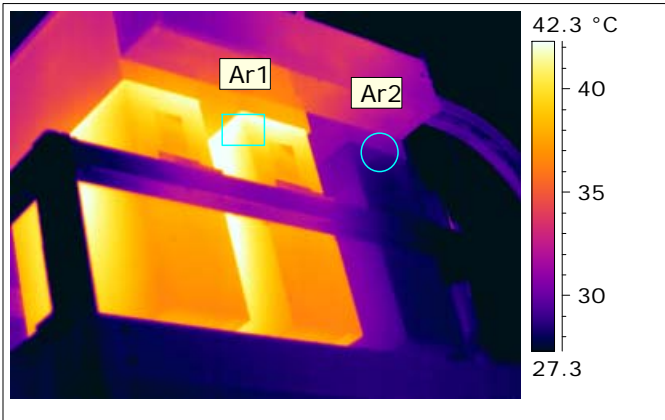
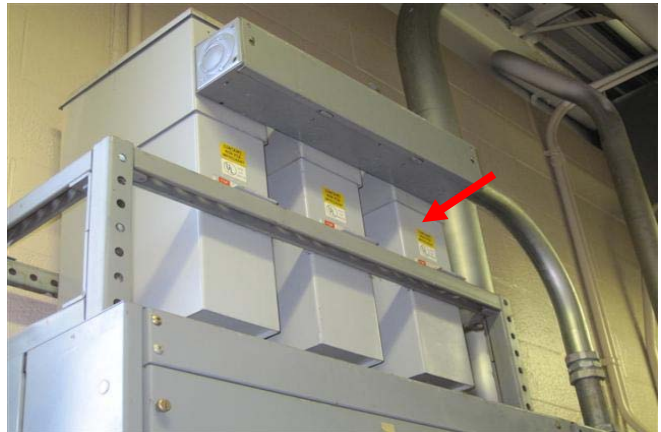
Object Parameters	Value
Filename	IR_3450.jpg
Maximum Temperature	43
Control Temperature	31
Temperature Rise	12
Severity	Intermediate

Location	Main Electrical Room Capacitor Bank Right Capacitor
Equipment	Capacitor Bank
Type	Capacitor
Image Date	8/6/2009
Image Time	7:23:02 AM
Recommendation	Repair Or Replace

It appears the capacitor on the far right is not functioning as it should. All fuses in the feed switch for the capacitor were functioning at the time of the inspection. Amp readings confirmed that the capacitor is not operational. The capacitor should be serviced and tested to insure that it is functioning properly.

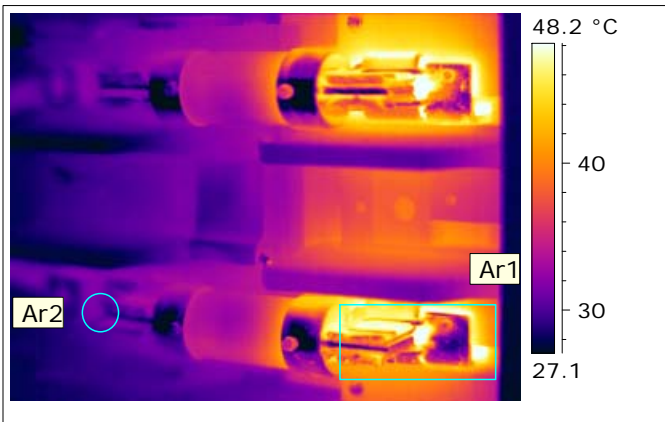
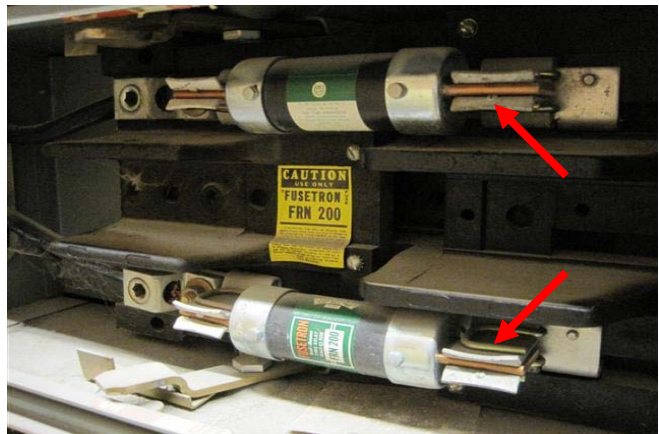
Object Parameters	Value
Filename	IR_4807.jpg
Maximum Temperature	51
Control Temperature	32
Temperature Rise	19
Severity	Intermediate

Location	Rear Of Facility 3d Distribution Section From Left 2nd Switch Down
Equipment	Panel H
Type	QMB-2220
Image Date	5/5/2010
Image Time	12:09:05 PM
Recommendation	"Clean, Lubricate and Exercise"

The top and bottom phase line side QMB switch to panel bus connection above shows a 19°C rise. Inspect the knife blade and pivot for arcing. Also inspect the connection on the bus of the distribution panel. It appears that the source of the heat is coming from behind the Bakelite This indicates a connection issue either at the bus or at the knife connection.

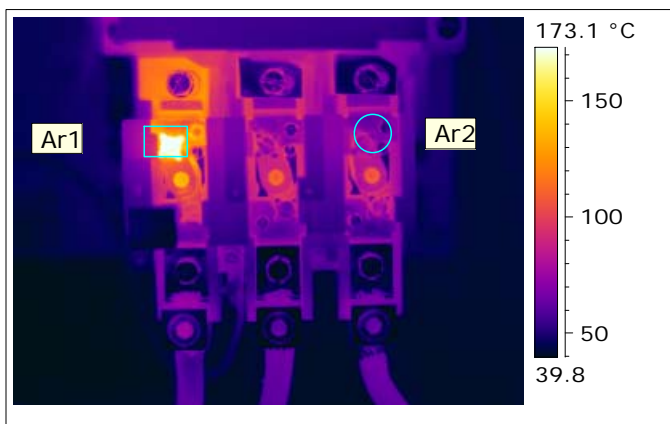
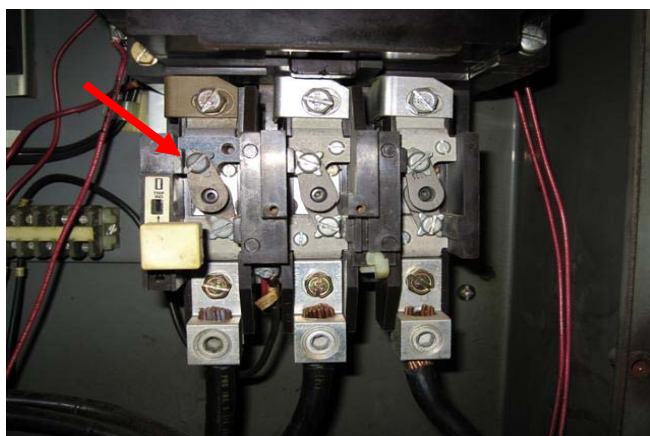
Object Parameters	Value
Filename	IR_4615.jpg
Maximum Temperature	191
Control Temperature	89
Temperature Rise	102
Severity	CRITICAL

Location	Compressor Room Compressor 1 Left Phase Overload Connection
Equipment	Compressor 1
Type	Overload Connection
Image Date	4/15/2010
Image Time	10:58:01 AM
Recommendation	Disassemble and Inspect Components

The top connection of the left phase motor overload heater under the main motor contactor shows a critical 101°C rise. This item was written up in the 1-07 report as a 72°C rise and later in the 1-08 report as a 51°C rise. The repair that was attempted from last years report was only minimally successful. Replace the entire overload block and overload heaters to keep this crucial piece of equipment operating.
